Do it Right, Do it Once

Little Things Can Make A Big Difference

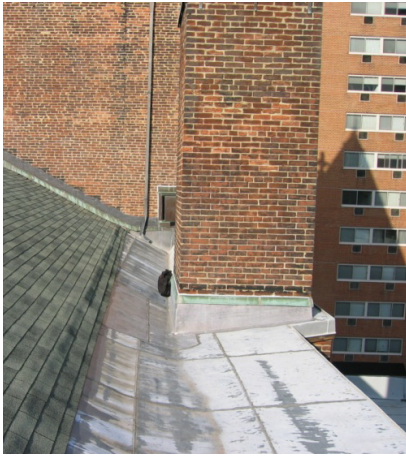
Flat seam lead coated copper gutter comprised of very large pans and suffering from fatigue cracks.

Is bigger better? When it comes to ice cream sundaes or TV screens, sure! When it comes to flat seam roof pans, not so much. Economy or misguided logic might lead a person to conclude that a flat seam roof made up of larger pans requires fewer pans and less labor to install or will have fewer seams to potentially crack and leak in the future. Large pans, however, often lead to premature failure of the roof.

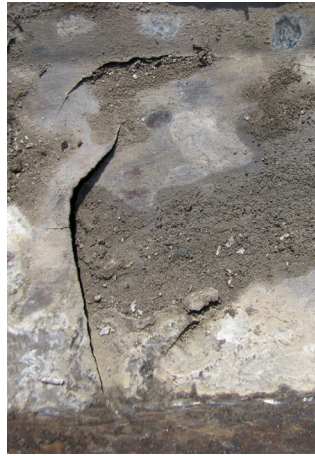
Fatigue cracks in a flat seam gutter formed from large pans with no expansion joints.

Correct pan size is not the only critical factor for a long-lasting flat seam roof. Metal gauge selection, seam dimensions, fully sweating the soldered seams, and properly detailed expansion joints (if the roof is larger than 30 feet in any direction) are also essential to the longevity of flat seam metal roofs, but these are topics for other newsletters!

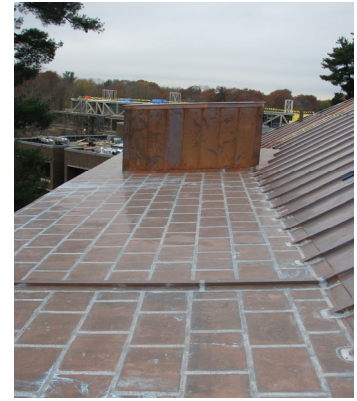
Flat seam copper roof comprised of pans no larger than 18"x24". Note also the expansion batten.

In flat seam metal roofs, the pans are cleated to the roof deck and locked and soldered together, which prohibits movement at the seams. In properly detailed flat seam roofs, the individual pans can accommodate a certain amount of thermal movement via "oil canning," whereby the surface of the pan flexes upward slightly when the metal heats up (i.e., when it expands) and flattens when the metal cools (i.e., when it contracts). Large pans can suffer severe distortions as a result of oil canning or may not be able to oil can enough, depending on their size. With oversized pans, the strain produced by thermal movement can cause the soldered seams to crack or fatigue cracks to form in the metal, thereby undermining the watertightness of the roof system. For this reason, industry standards, such as Revere Copper Product's *Copper and Common Sense*, limit the size of flat seam roof pans to a maximum of 18"x24" (prior to hemming the edges). Based on the formula above, a pan of this size will expand/contract less than 1/16" per year in each direction.
